# 100 m of 1970s piping screened in place and mapped in 3D — without cutting, draining or dismantling

FISHERIES AND OCEANS CANADA

CAPILANO RIVER HATCHERY · NORTH VANCOUVER, BC · AUGUST 2026

*Pulsed eddy-current and eddy-current-array screening through original coatings, registered to a LiDAR + photogrammetry model in HELIX Horizon.*

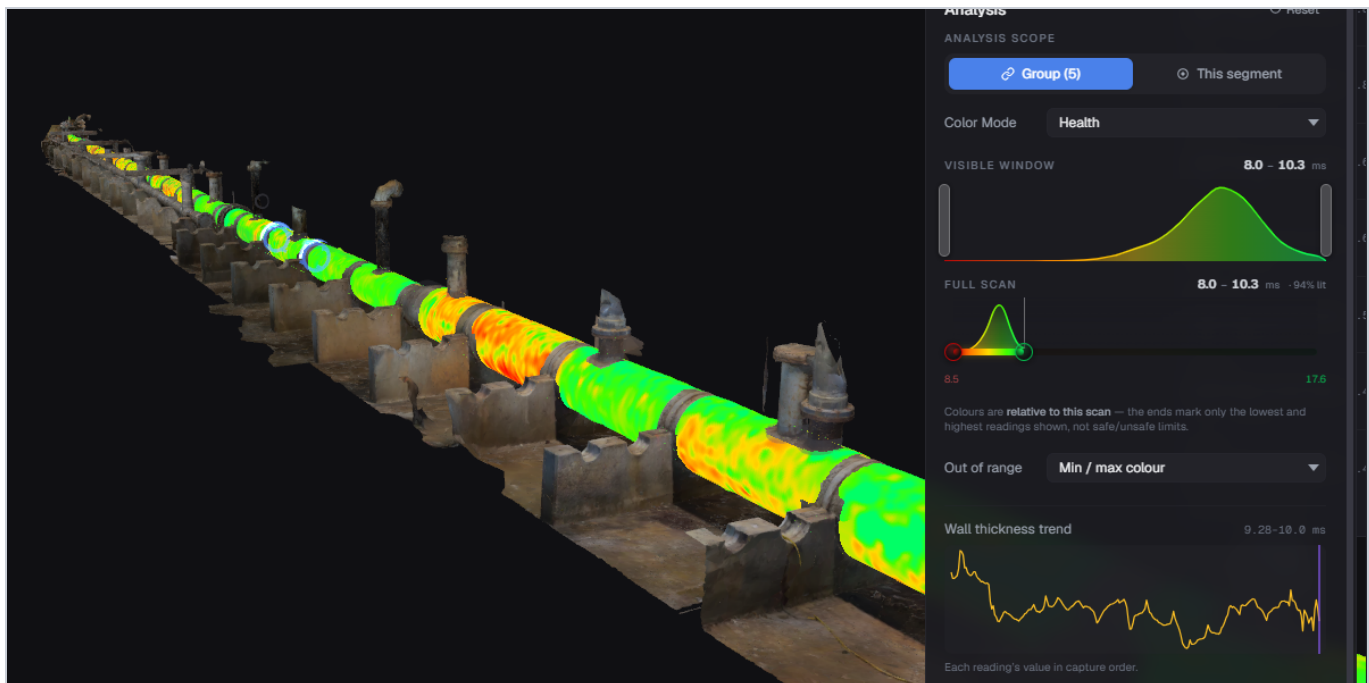
*PEC results mapped over the captured geometry, with per-zone histogram analysis — HELIX Horizon.  
Colours are relative to this scan — they mark the lowest and highest readings shown, not safe/unsafe limits.*

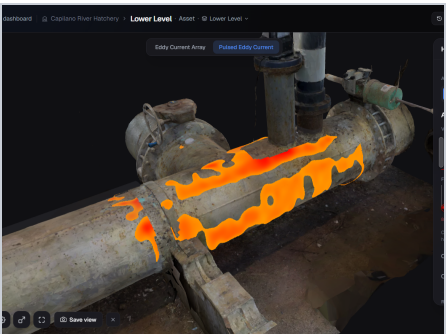
Searching the scan: the visible window narrowed to the lowest band — only those readings stay painted, in place on the asset. Colours are relative to this scan — not safe/unsafe limits.

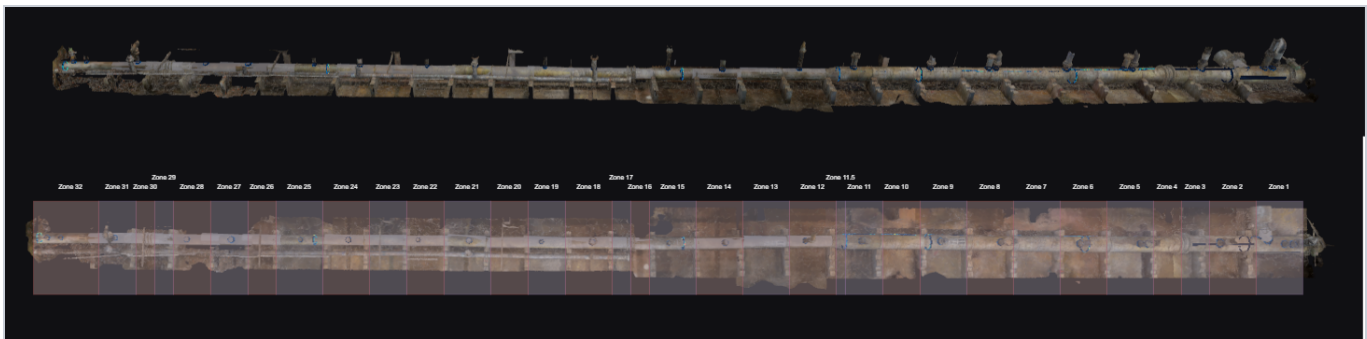
- Relative wall thinning along the top of the wastewater line — clearest across Zones 10–11, and into Zone 2 at the outlet
- Deposit or corrosion-product bands along the invert of Zones 4–6, where the high reading itself hides whatever wall is left underneath
- An unconfirmed material boundary from Zone 12 onward, and one half-metre section (Zone 29) reading about 2.1× its neighbours
- On the 4-inch line: repeatable dents and scrapes recorded as monitoring baselines; blistered, probably lead-containing coating flagged for direct examination

*The 24-inch line divided into numbered inspection zones — every finding above is located against this map.*
